FINAL REPORT
APRIL 1996

REPORT NO. 95-01

PALLETIZED LOADING
SYSTEM (PLS) FLATRACK
SIDEBOARD KIT
EVALUATION

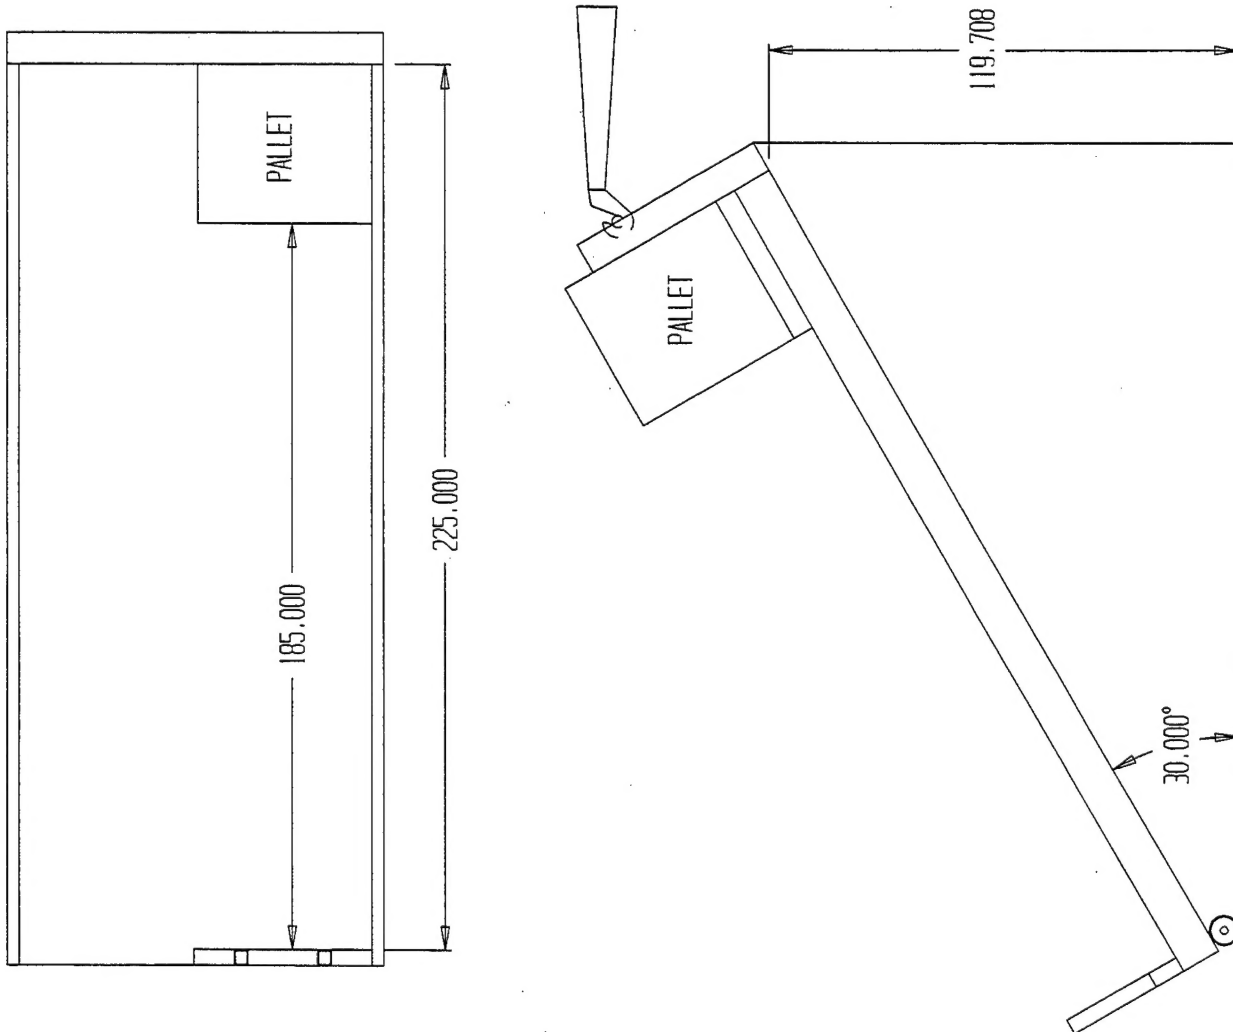
Figure 1

The M1077 flatrack was raised to 119 inches before the pallet overcame static friction (see Figure 1, page 4-2). The pallet slide path was 185 inches to the rear sideboard. The critical angle was 31 degrees.
